*Technical Data Sheet*

Bridge Identification:	1620310000000B01
Facility Carried:	M 37
Feature Intersected:	Muskegon River
Location:	Newaygo
County:	Newaygo
Region:	Grand
Year Built:	1953
Year Reconstructed:	1987
Bridge Type:	Two-Girder System
No. of Spans:	5
Deck Area:	34,780 S.F.
Paint System:	Type 4
Paint Area:	97,000 S.F.

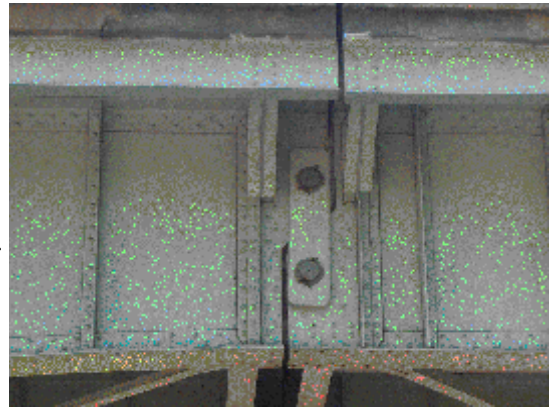
Typical Pin and Hanger Assembly (3)

**! Pin and hanger assemblies.** (Photo 3)

Powerwash bearings and pin and hanger assemblies.	12 months
---	-----------

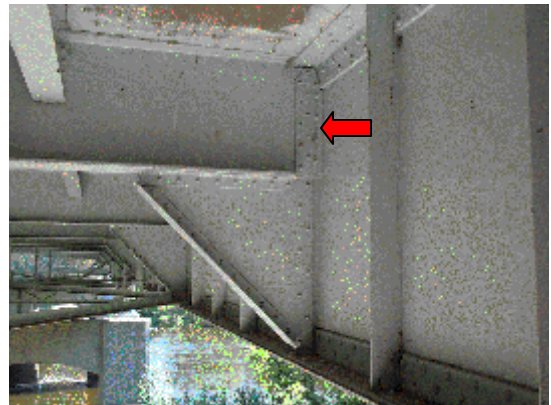
Typical Connection of Floorbeam to Girder (4)

**! Girder webs at floorbeam connections.**

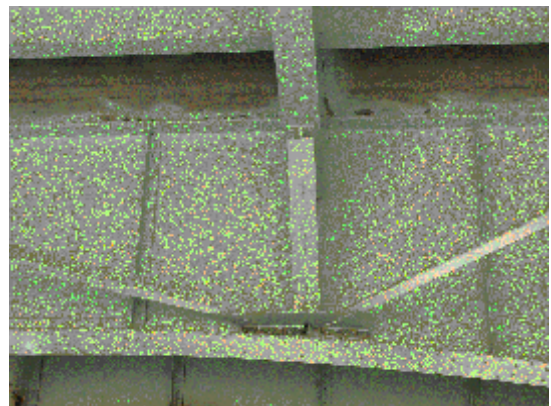
Lateral Bracing at Floorbeam Connection (5)

**! Lateral bracing gusset plates at floorbeam connections.**

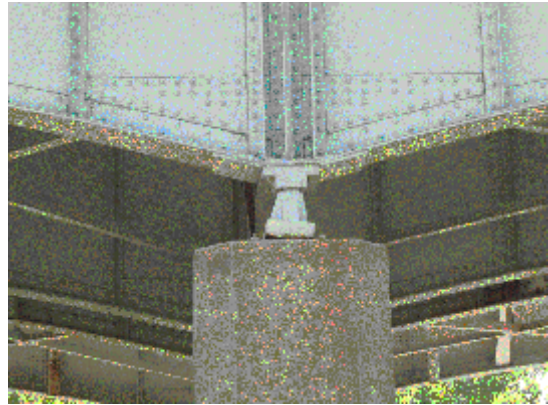
Typical Inclined Rocker Bearing at Pier (6)

- ! Bearing assemblies.** The bearings at Piers 1 and 4 appear to be excessively inclined for ambient temperature and should be monitored.
